Weekly Construction Report

Hatchery Creek Design/Build Project

Time Period:	November 1-7, 2015	Project No:	1305
Rain Days/Weather Conditions:	Rained 0.5" on Friday (Burkesville gauge). However, we were able to work both Friday on Saturday on limited areas.		
Personnel on-site:	<i>EcoGro/Ridgewater:</i> Tom Cutter, Eric Dawalt, Jim Hanssen, Larry Mounce, Brad Redmon, Chad Relinski, Randall "Mokie" Starns, Randall Starns, Jr., Sherri Arthur Trucking-John Arthur.		
Equipment on-site:	Komatsu PC 360 excavator w/ hyd. thumb, Komatsu PC 160 w/ hyd. thumb, Komatsu PC 210 excavator, Komatsu PC 240 excavator, Terex TA27 articulated off-road dump truck, Bobcat T300 skid steer, & Morooka 2200 track dump truck.		
Material deliveries to project site:	<ul style="list-style-type: none"> 143 tons of spawning gravel (1,802 tons to date). This completes contract amount of 1,800 tons. ~150 tons of #8 stone for culvert bedding and backfill. ~222 tons of 24" dia. rock for boulders and ravine spillway.

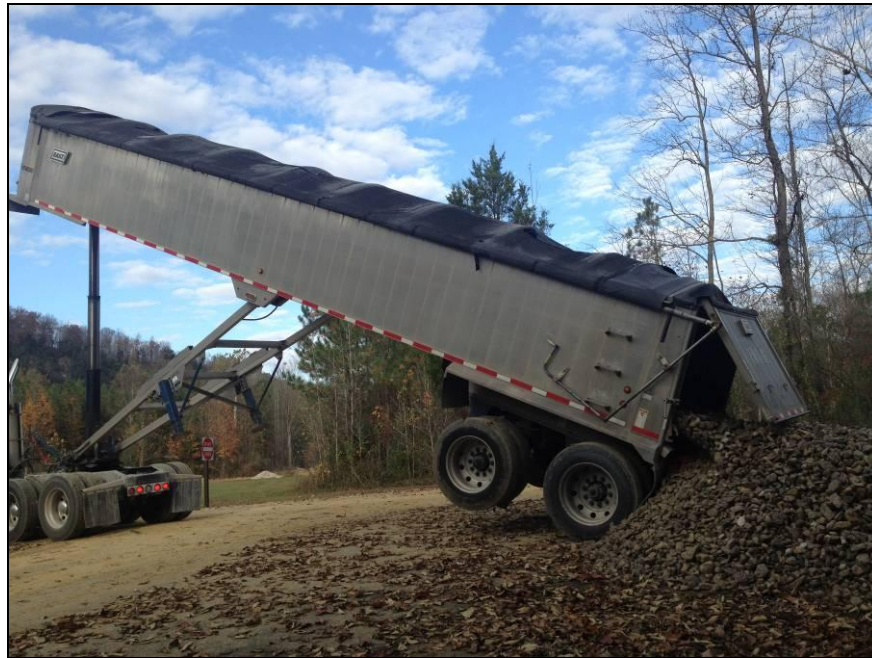
Delivering spawning gravel to the site. (Picture taken on Campground Road).

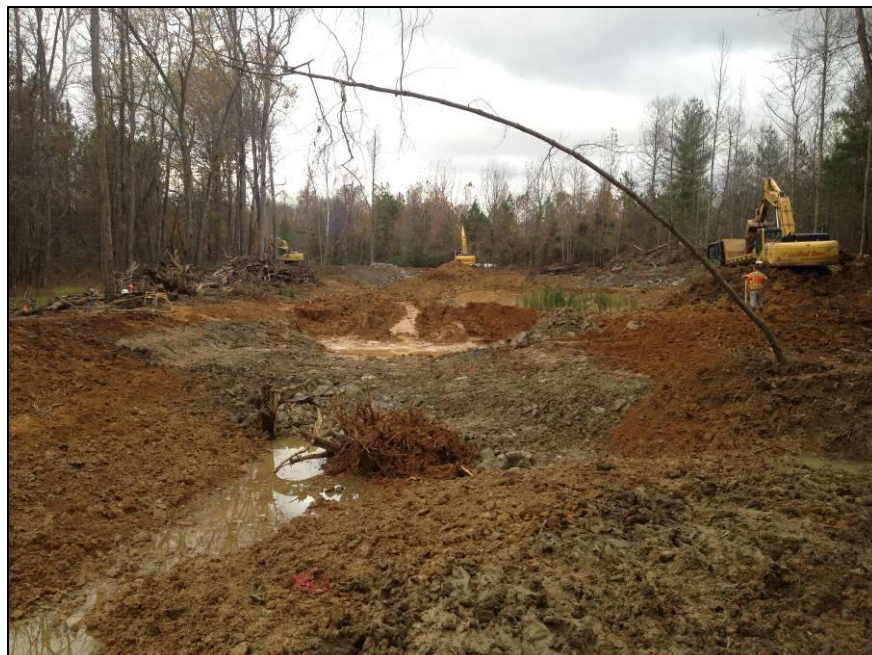
Reach upstream of Campground Road: Riffle in center of picture is being built out of shot rock, at upstream end of braided channel. (Picture taken from ~Sta. 113+00 looking downstream).

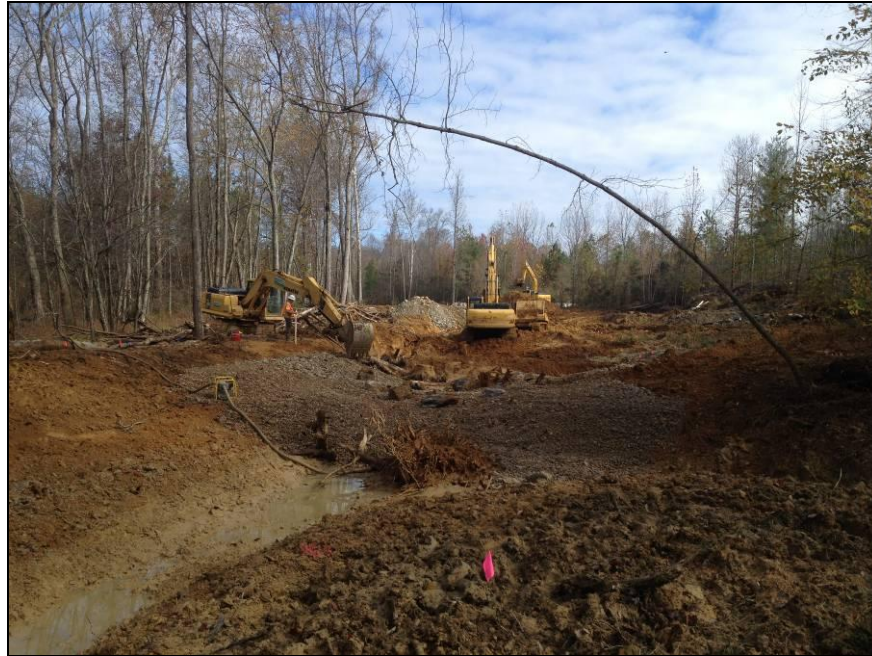
Reach upstream of Campground Road: Riffle in center of picture has been covered in spawning gravel and boulders. Soil is being excavated from the channel in the background. (Picture taken from ~Sta. 113+00 looking downstream).

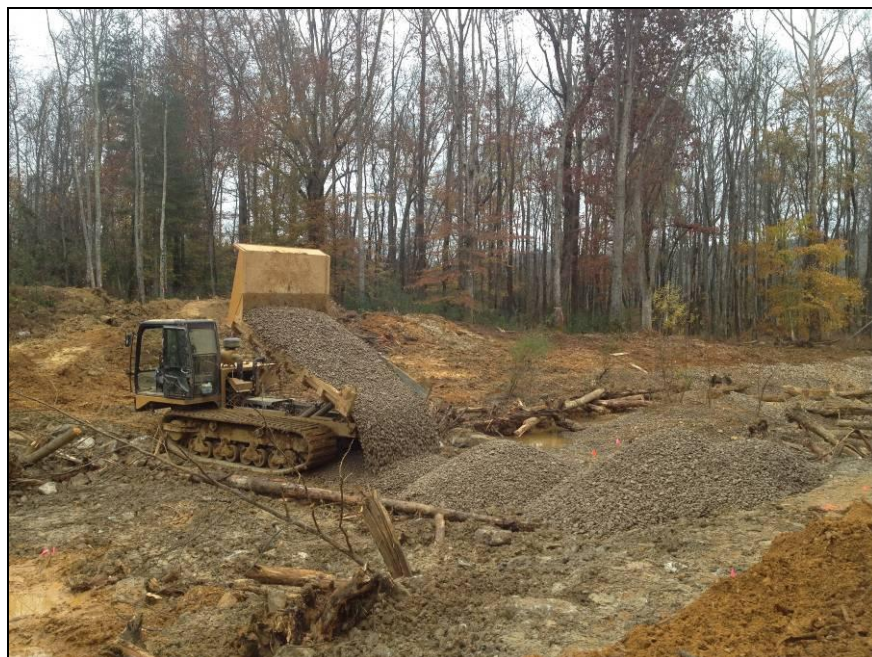
Reach upstream of Campground Road: Hauling spawning gravel into stream. (Picture taken from LDB at ~Sta. 114+50 looking upstream).

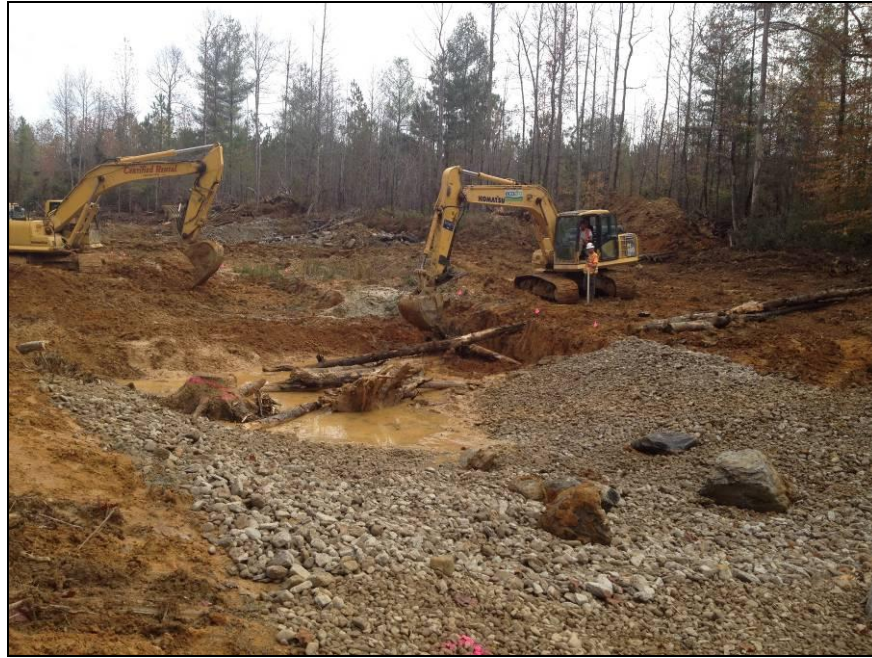
Reach upstream of Campground Road: Installing wood in banks for wood/rock toe in pool. Soil is being excavated from the channel in the background. (Picture taken from LDB at ~Sta. 113+50 looking downstream).

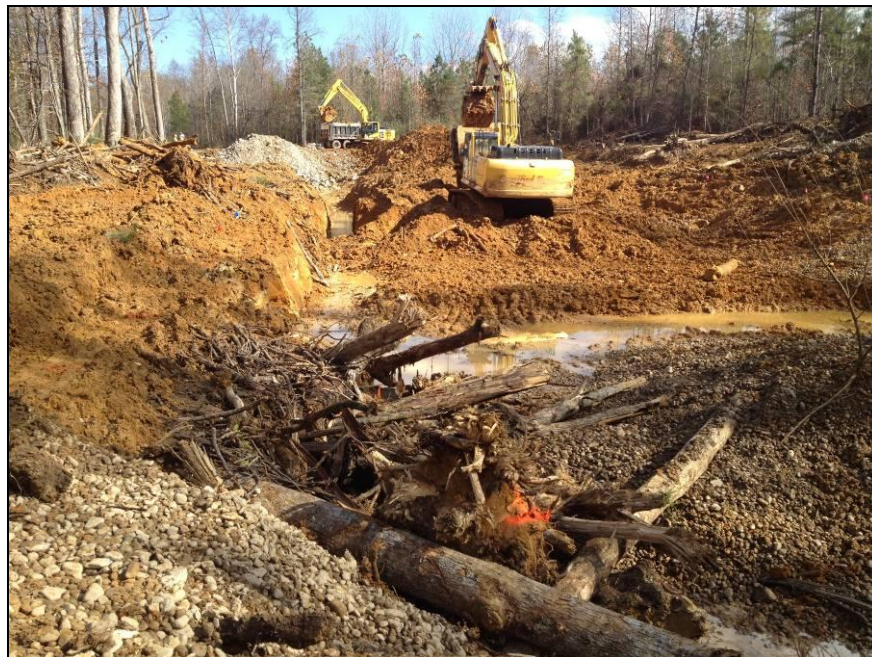
Reach upstream of Campground Road: Close-up picture of wood installed in banks for wood/rock toe in pool, before rock is added. Soil is being excavated from the channel in the background. (Picture taken from LDB at ~Sta. 114+00 looking downstream).

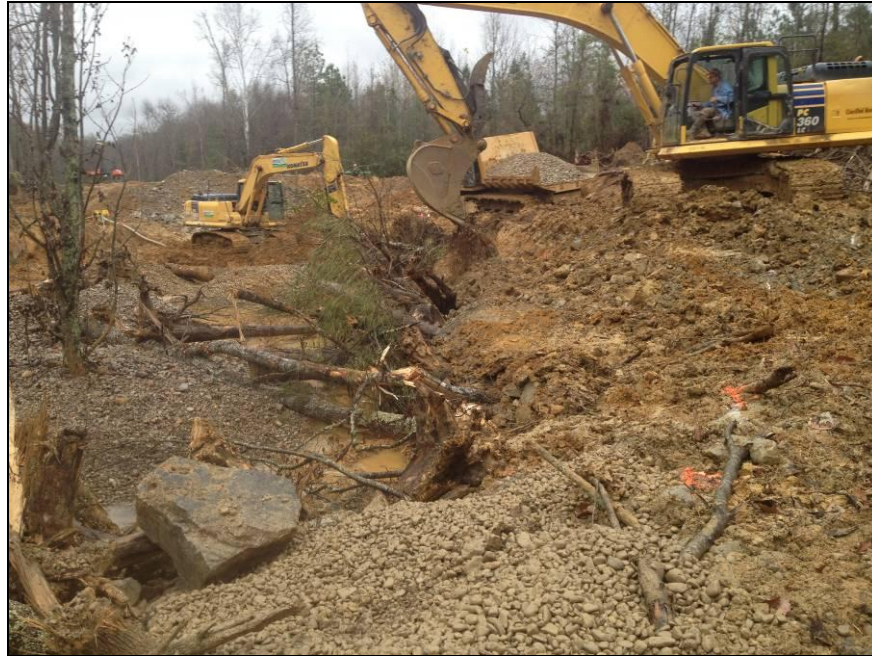
Reach upstream of Campground Road: Installing shot rock to anchor wood in the banks for wood/rock toe in pool. Spawning gravel will be installed over the shot rock. (Picture taken from RDB at ~Sta. 114+50 looking downstream).

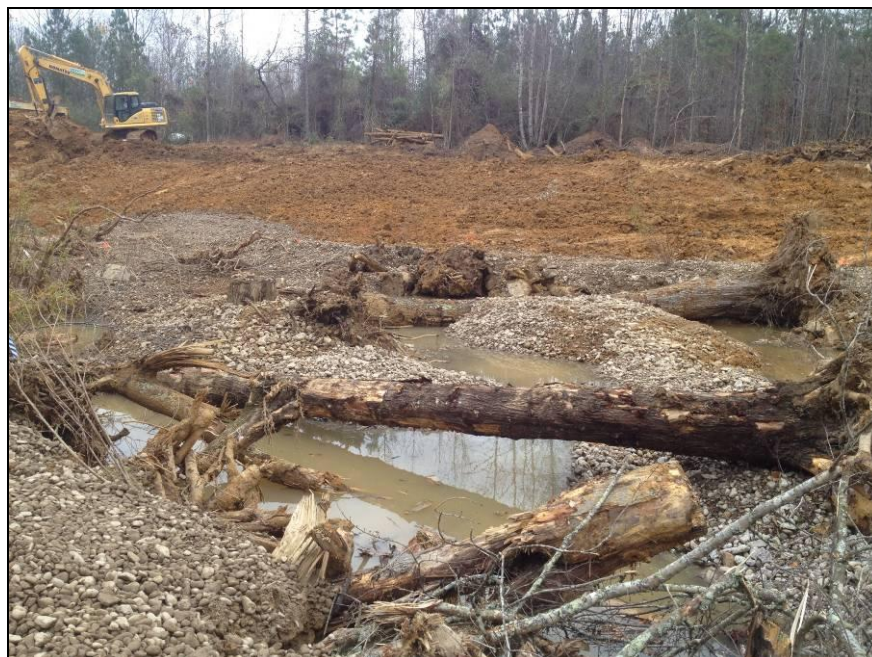
Reach upstream of Campground Road: Completed pools in braided channel reach with logs, rootwads, and spawning gravel for habitat. (Picture taken from LDB at ~Sta. 115+00 looking across the channel).

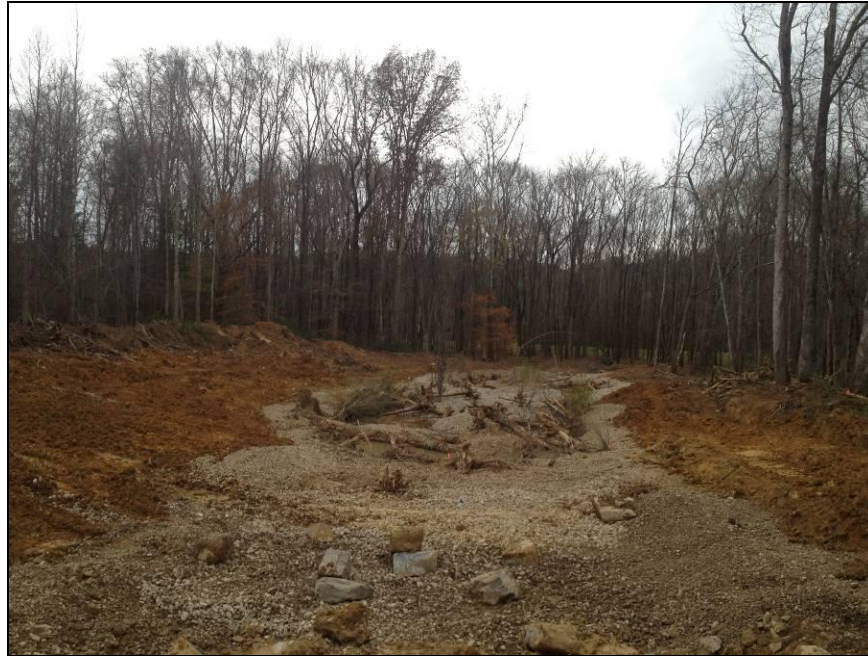
Reach upstream of Campground Road: Completed braided channel reach, prior to water filling stream. (Picture taken from Campground Road at ~Sta. 117+50 looking upstream).

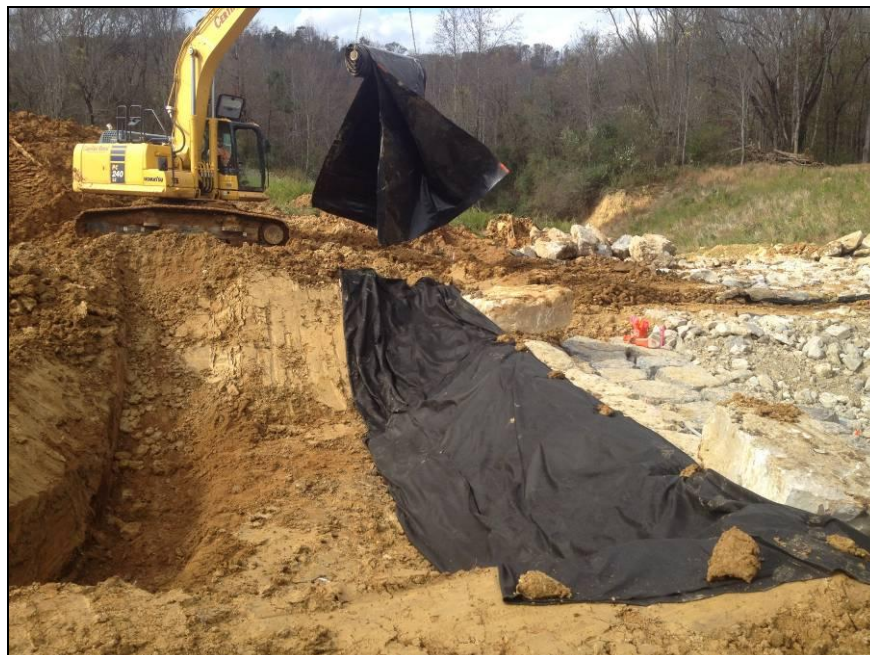
Migration Barrier: Geotextile fabric has been installed upstream of the migration barrier step. HDPE liner is being brought in to install over geotextile. (Picture taken from RDB at ~Sta. 105+80 looking across channel).

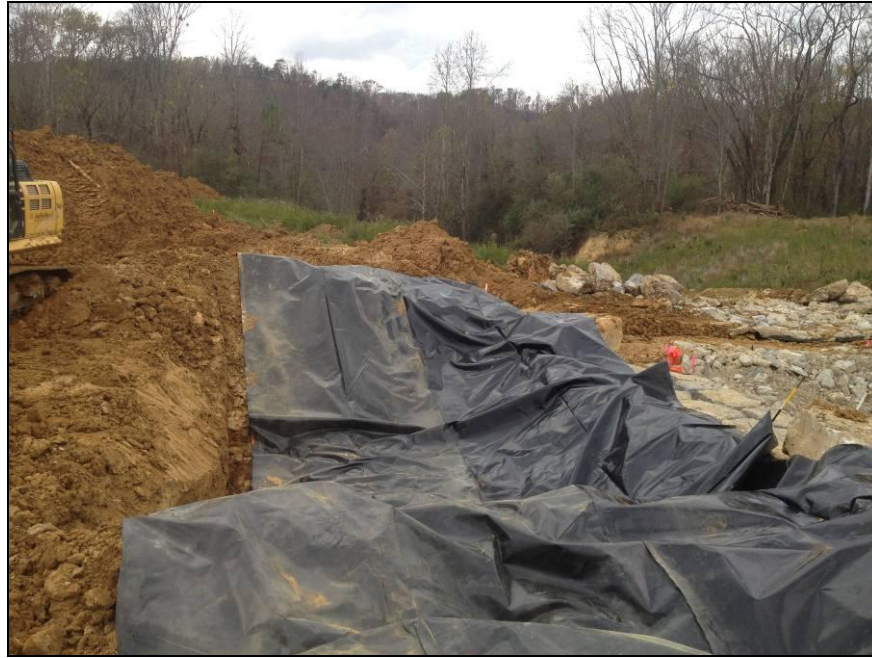
Migration Barrier: HDPE liner being installed upstream of the migration barrier step. Upstream edge of liner was installed in a trench. (Picture taken from approximate same location as above).

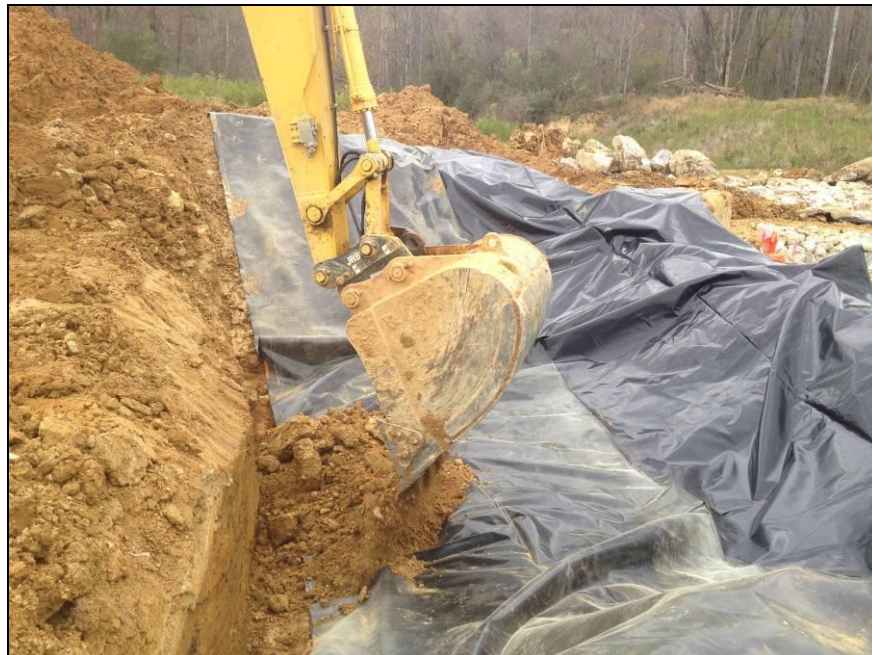
Migration Barrier: HDPE liner being covered with 12" of clay. (Picture taken from approximate same location as above).

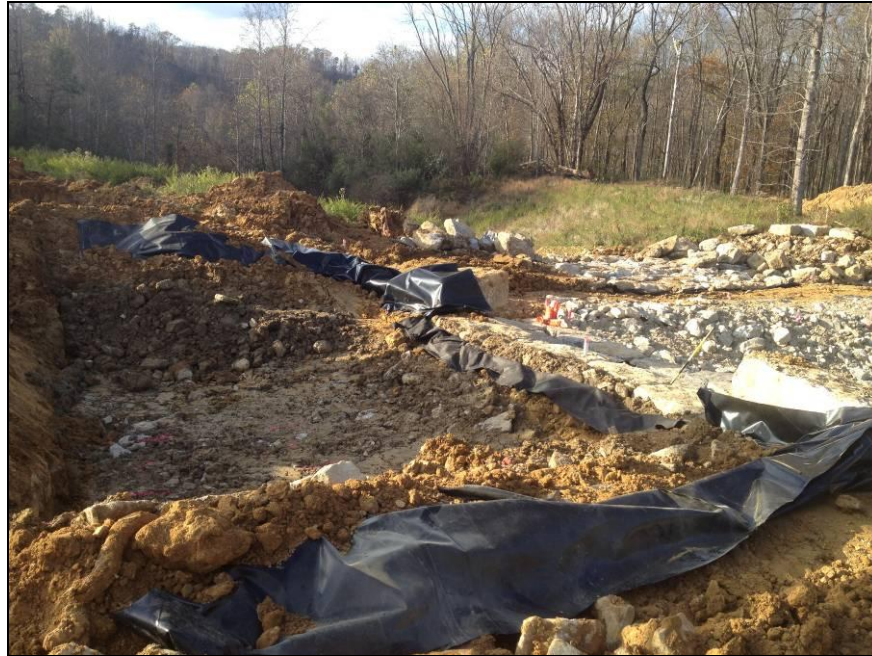
Migration Barrier: HDPE liner covered with 12" of clay and being covered with 12" of rock on bottom and sides. (Picture taken from approximate same location as above).

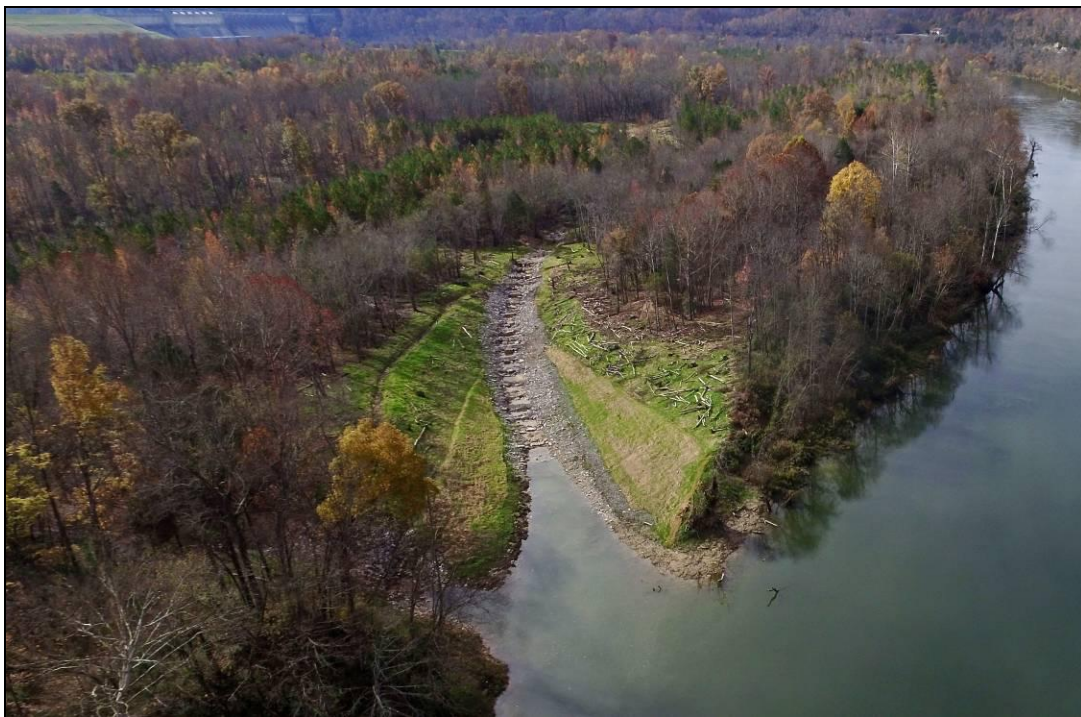
Aerial photograph of Site #3/step pool reach. U.S. Army Corps of Engineers Wolf Creek Dam can be seen in background. (Picture taken from above Cumberland River looking southwest).
